Uniform Mitigation Verification Inspection Form

Inspection Date: September 20, 2010		
Owner Information		
Owner Name: <u>Whispering Sands Condominium Association Inc</u>	Contact Person:	
Address: <u>199 Whispering Sands Dr</u>	Home Phone:	
City: <u>Sarasota</u>	Zip: <u>34242</u>	Work Phone:
County: <u>Sarasota</u>	Cell Phone:	
Insurance Company:	Policy #:	
Year of Home: <u>1970</u>	# of Stories: <u>3</u>	Email:

199 Whispering Sands Dr.

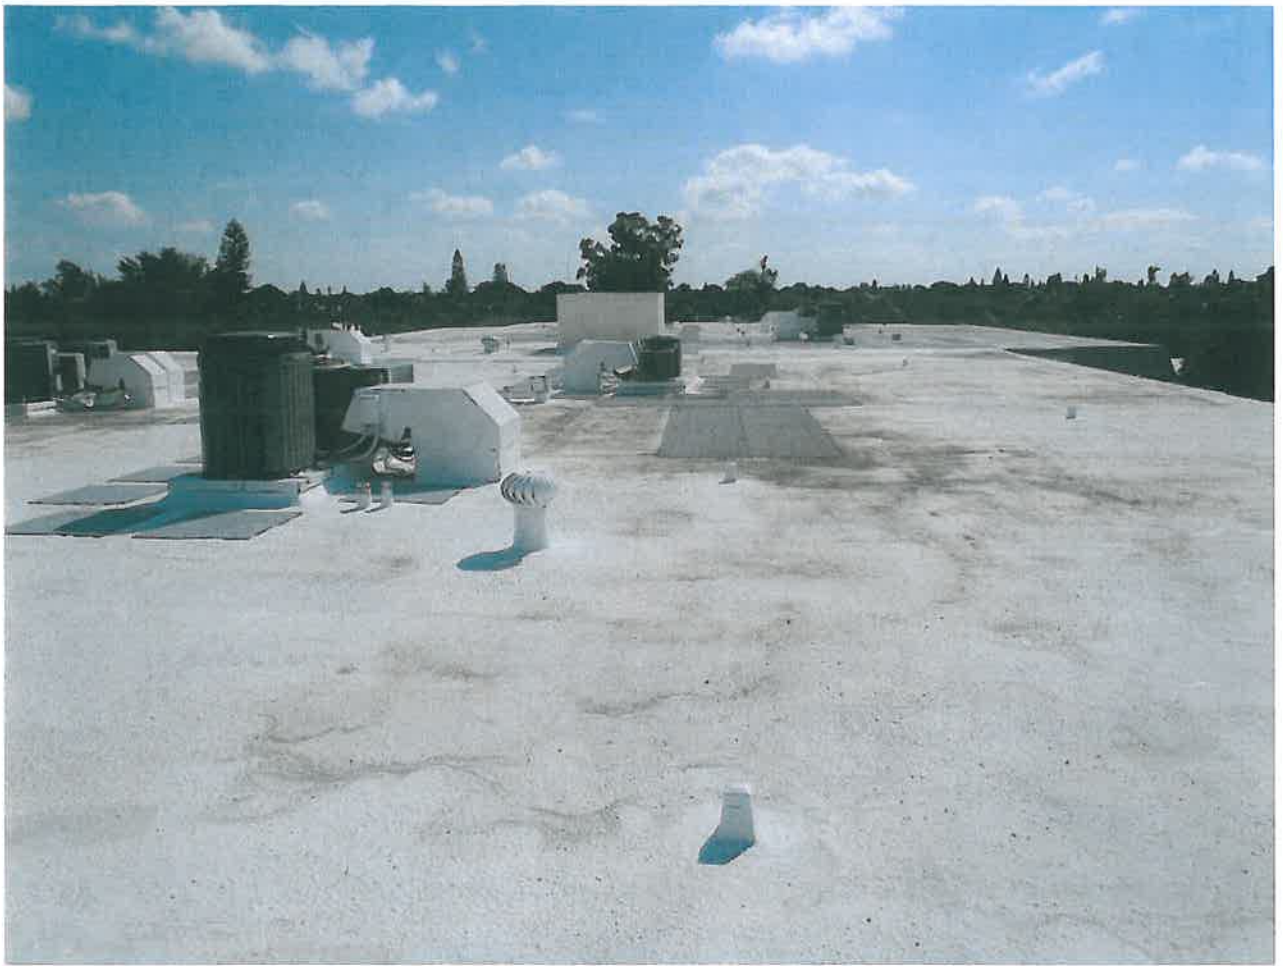
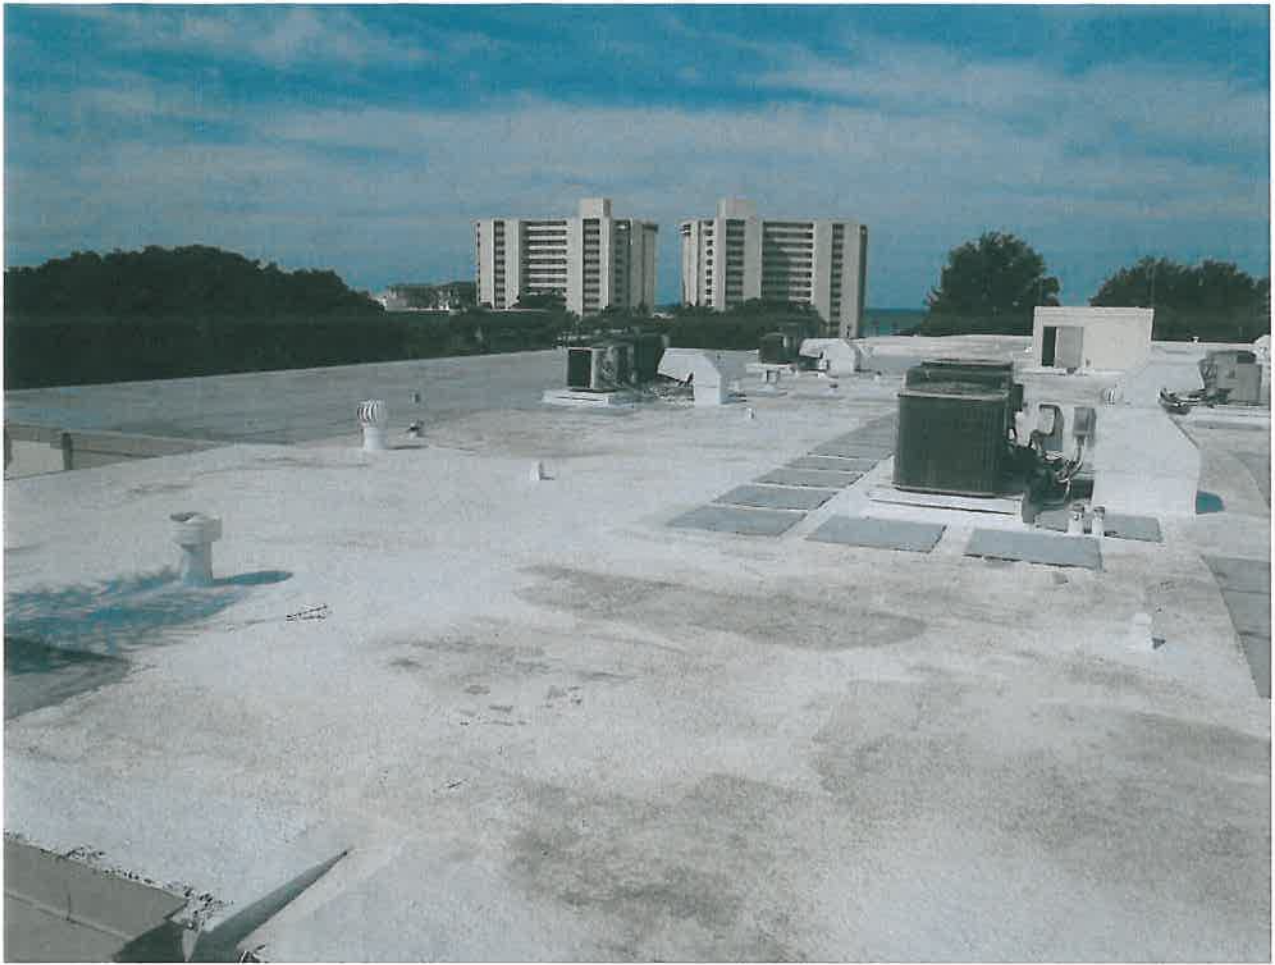
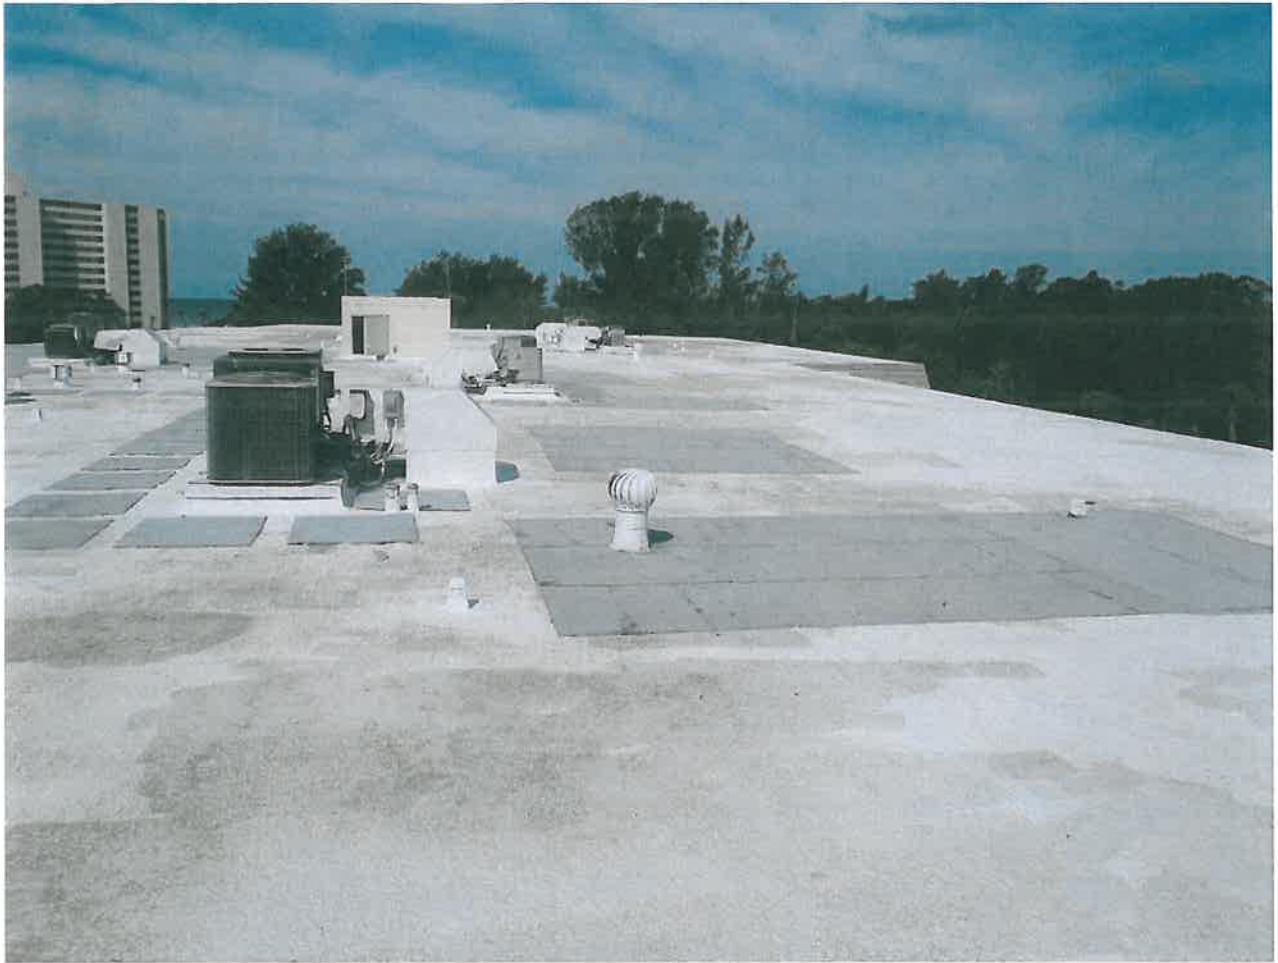
ROOF

Year Roof Was Installed _____ 2001 FBC. Yes No
SWR Barrier: Yes No Peel/Stick 2007 Hot Tar Foam/Adhesive
Roof Shape: Hip Gable Flat Mansard Other _____
Gable Ends 2001 FBC. Yes No

ROOF DECK

Plywood OSB Planks Concrete Other No Access
 1/2" 3/4" Other _____ No Access Other _____
 Staples 6d Nail 8d Nail 10d Nail Screw Other _____
 5/6 5/12 >6/12 Roof Slope /12

ROOF STRUCTURE

Wood Trusses Rafter Metal No Access

ROOF TO WALL CONNECTION

Clips Single Wrap Toe Nail Double Wrap Unk

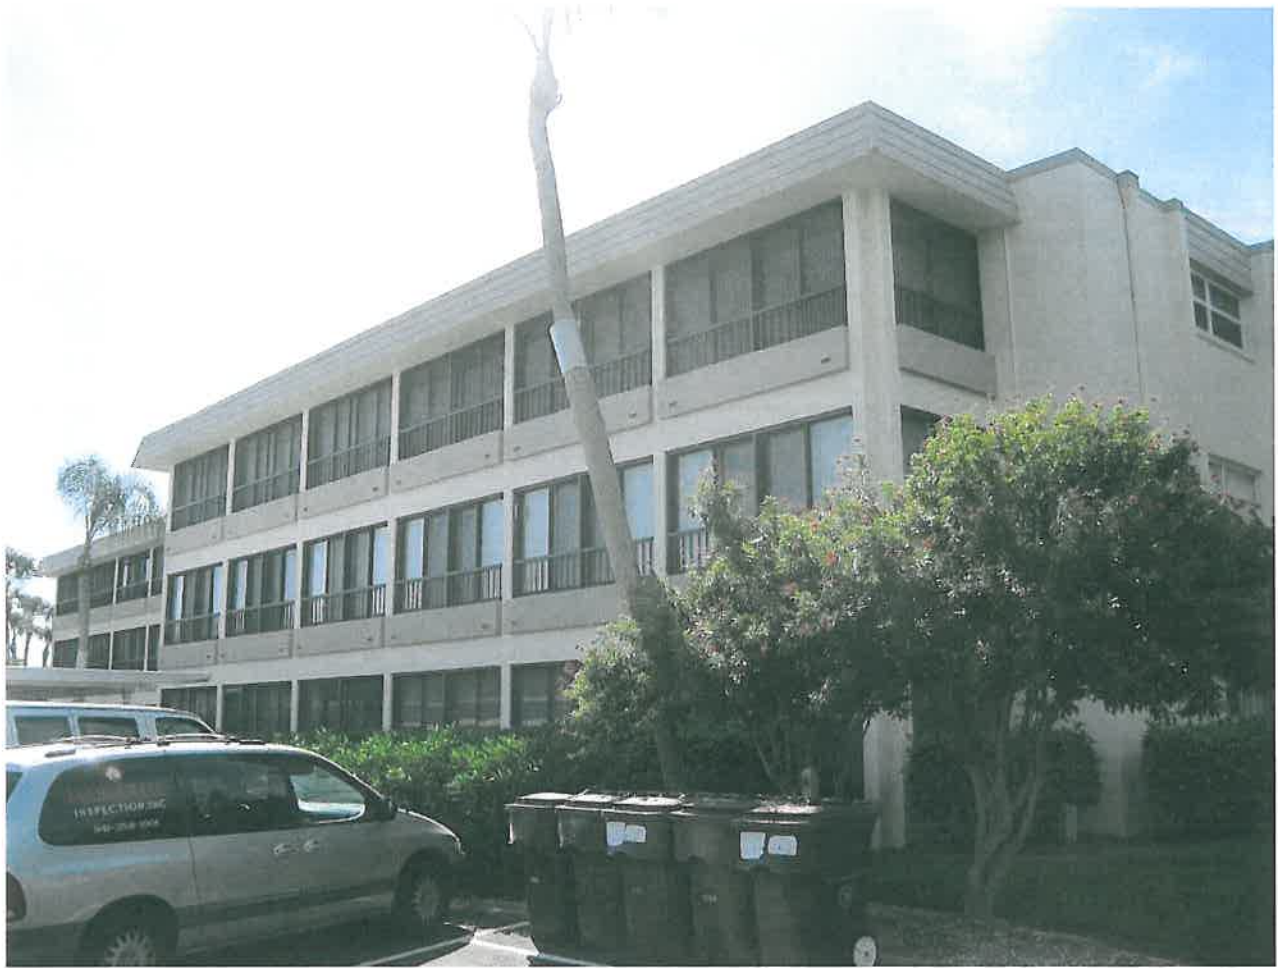
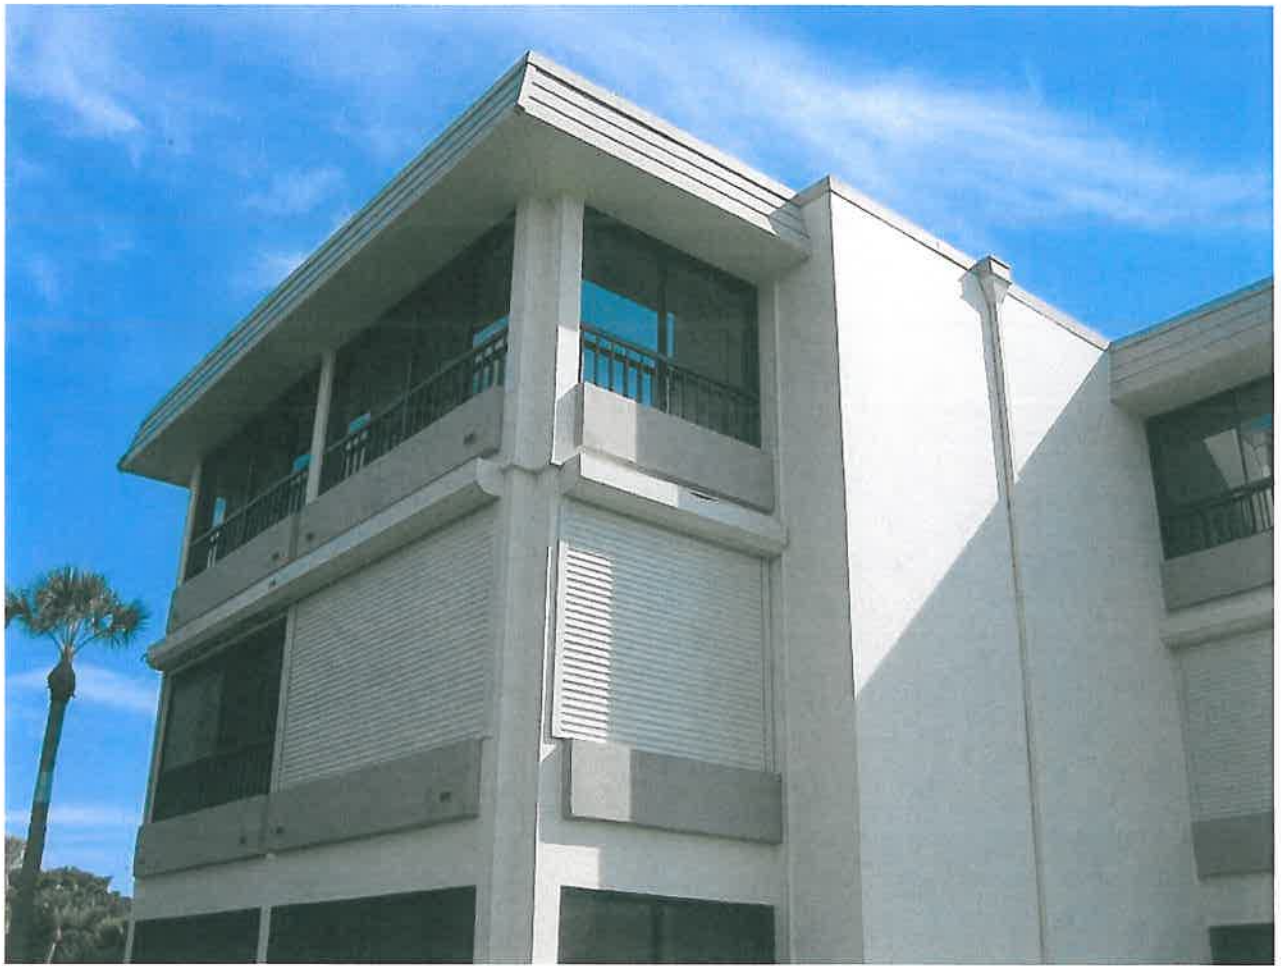
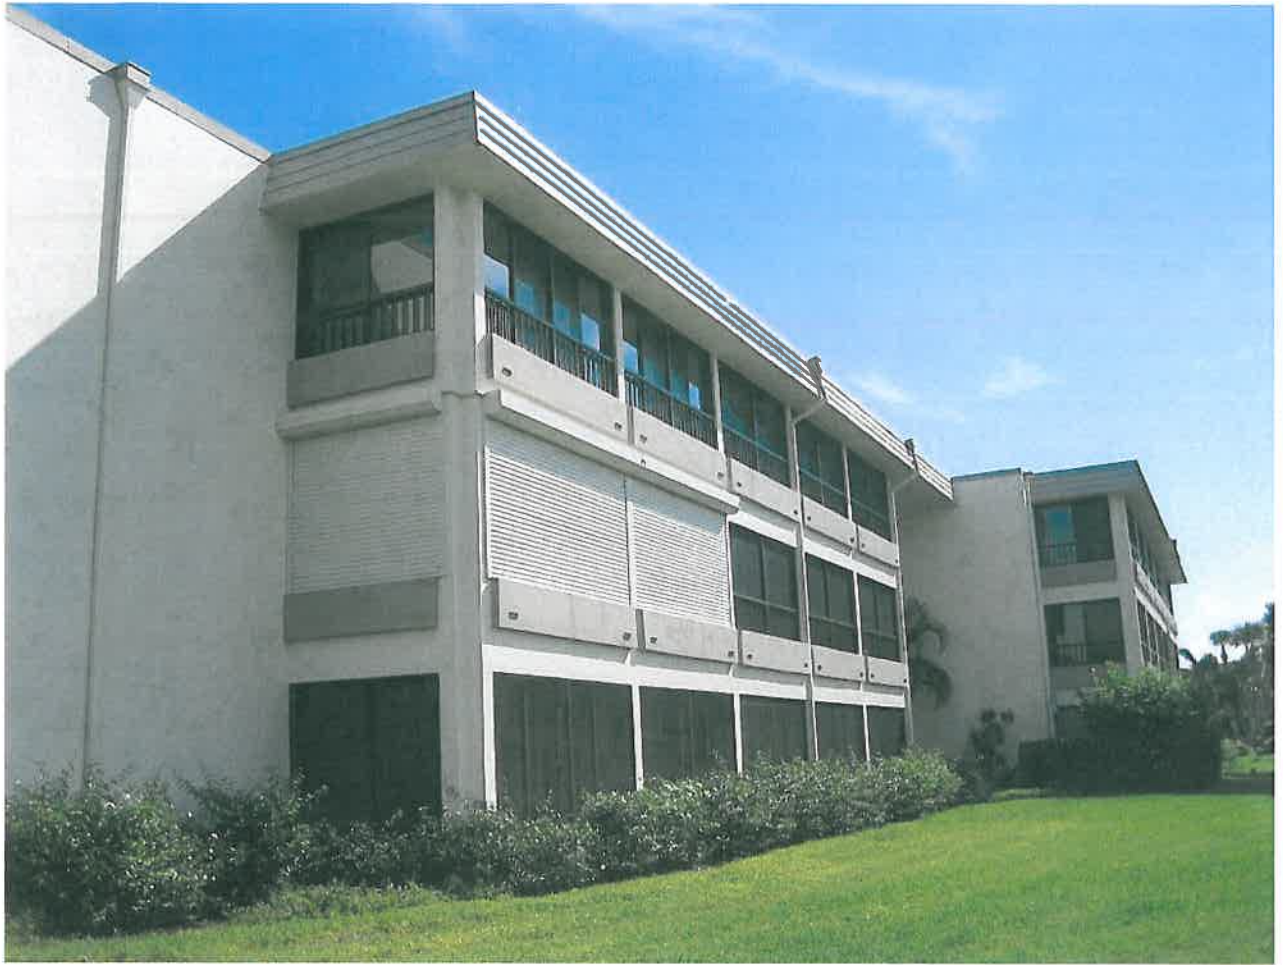
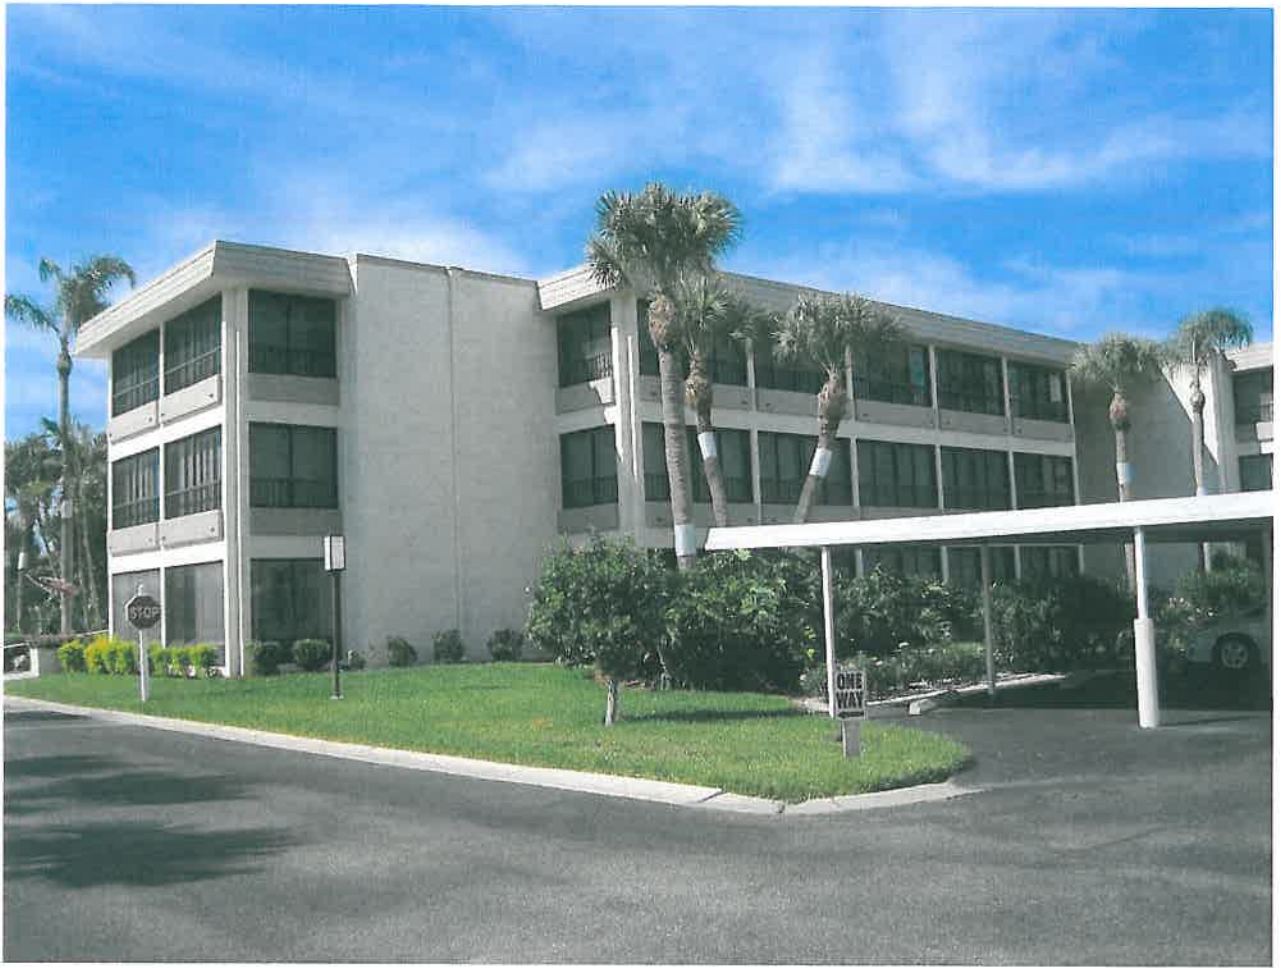
ROOF

Installed _____

2001 FBC: Yes No

Peel/Stick

2007 Hot Tar Foam/Adhesive

Hip Gable

Flat

Mansard
